Building Performance Evaluation Programme: Findings from non-domestic projects

Getting the best from buildings

January 2016

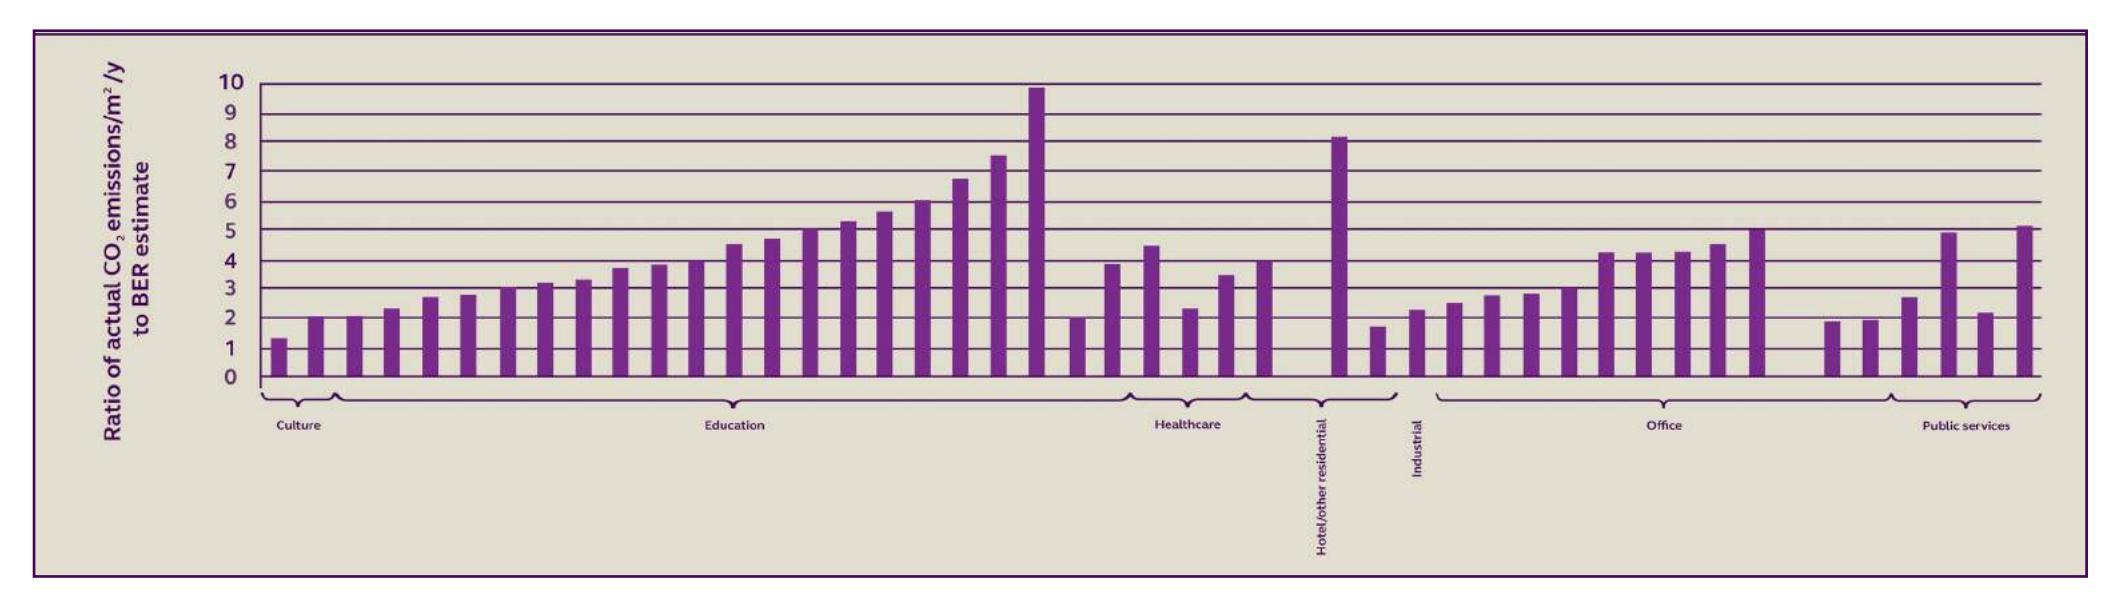
Fig. 2: Actual CO_2 emissions are almost always higher than the BER predicts (Carbon Factors: Electric 0.55kg CO_2 /kWh, Gas 0.194kg CO_2 /kWh, Oil 0.265kg CO_2 /kWh, District heating 0.265kg CO_2 /kWh, Biomass 0.025kg CO_2 /kWh, from BRUKL). NB: Zero-rated buildings against one hotel and one office project are projects with CO_2 data but no BER.

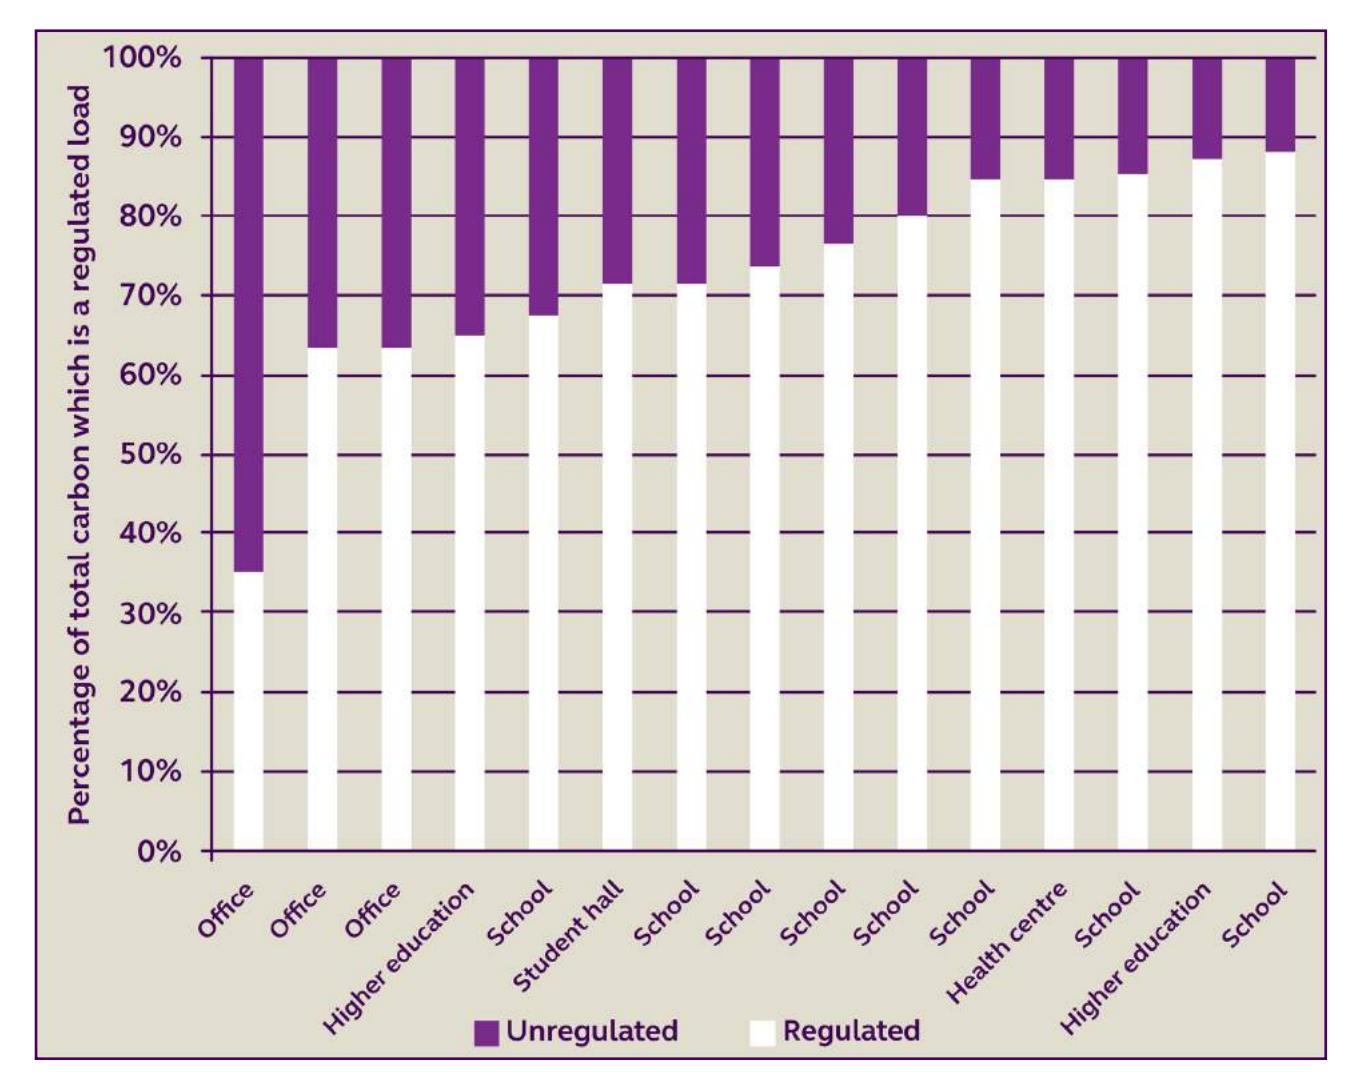
Fig. 3. Unregulated energy use can be as much as 65% of total actual energy use (Source: Cohen, 2013).

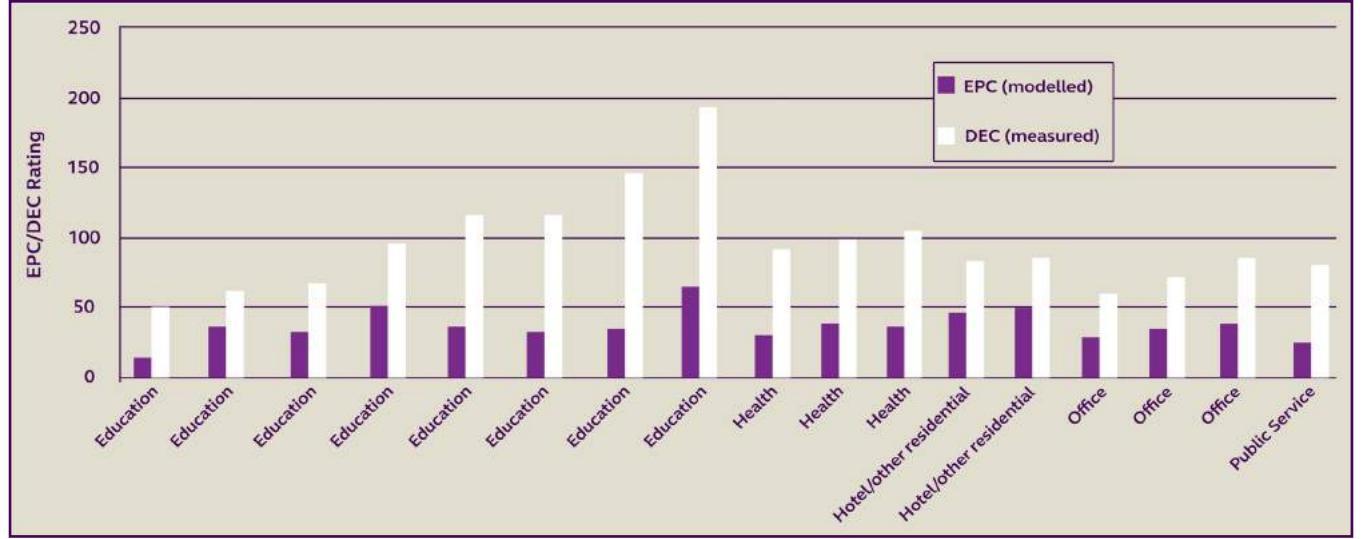
Fig. 4: Display Energy Certificate (DEC) ratings, based on measured energy use from bills, are often triple the modelled Energy Performance Certificate (EPC) ratings.

The graphs in figs. 4 and 5 simply compares EPC and DEC ratings for the 17 buildings with both certificates. This shows very little correlation between the EPCs and DECs, as noted in previous papers³. There is a slightly higher correlation coefficient for schools. This is mostly due to an outlier (an observation that is abnormally distant from other values) with a DEC of 193 (G), which also had a relatively poor EPC of 64 (C).

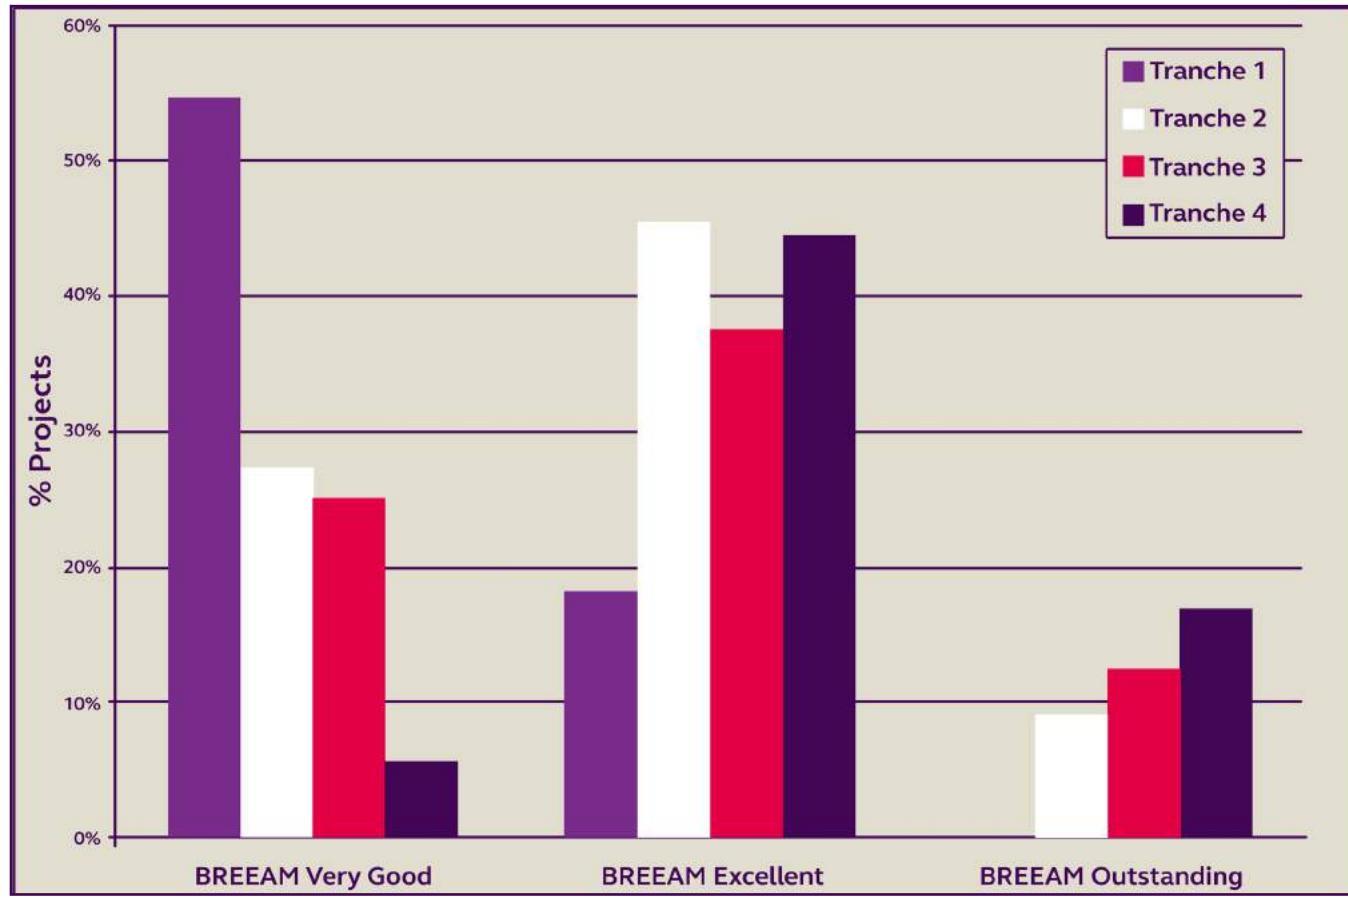
Fig. 6: The proportion of projects at BREEAM 'Very Good' fell over time, while those at BREEAM 'Excellent' and 'Outstanding' increased for later BPE project tranches.

The buildings in the study are self-selected. However, it is interesting to note that over 50% of projects in the first set to be monitored (Tranche 1: May 2010) were only achieving BREEAM 'Very Good'. Ten months later (Tranche 4: February 2011), most submitted projects were either BREEAM 'Excellent' or 'Outstanding'. It should be noted that BREEAM 'Outstanding' only came in for BREEAM 2008 generally, so this may have not been an option for earlier tranches. However, BREEAM standards have become stricter over time. For example, since 2008, the standard has required a Post Construction Review.

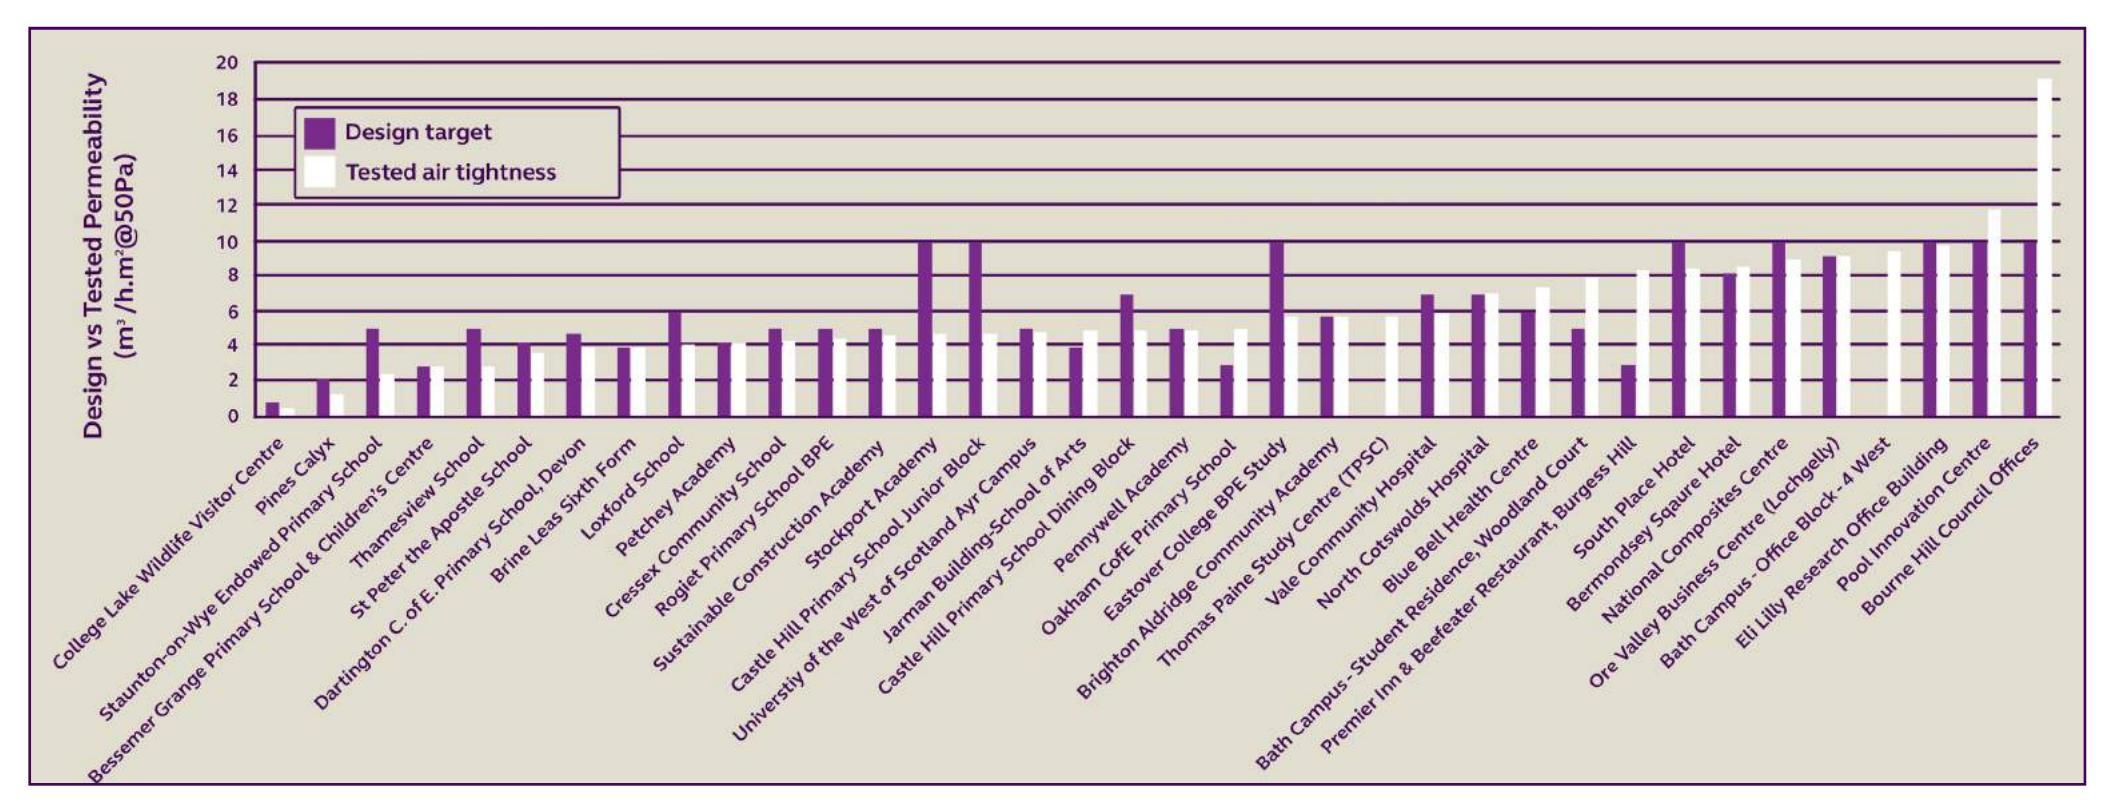
Fig. 9: Broadly, the buildings with the best airtightness (to the left in this graph) are those with the toughest design targets. Many of those with unexceptional targets (in the middle) did much better than their targets. The Ore Valley Business Centre – with poor airtightness – measured at 19.27 m³/h.m²@50Pa, which is equivalent to an air change rate of 6 air changes per hour. It had much better airtightness for individual rooms. However, settlement affected the whole building, and there are serious leaks, especially in the basement.

Every project reporting airtightness test results showed that they comply with the current Building Regulations, with lower infiltration. However, not all achieved their design targets.

Each project had a design target 'air permeability', as part of the BRUKL report completed for Part L of the Building Regulations. This measures unwanted infiltration of warm or cool air through gaps in construction and/or materials, when a building is pressurised to a 50 Pascal differential above the air pressure outside. Of the non-domestic projects, 36 provided the results of actual airtightness tests. All but one of these also reported a design target for airtightness.

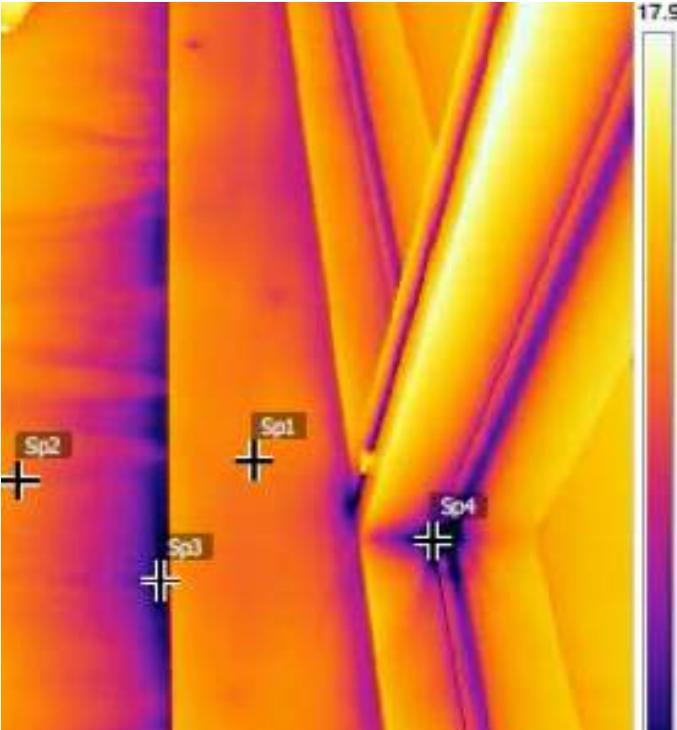
Fig. 13: Air infiltration (draughts) seen at the junction between the floor and full-height window frames, and between the window frame and pane, at Thamesview School.

Thamesview School	The survey showed some good detailing and construction, including expansion joints in the external wall, at the wall/ground floor junction, and in most of the door/window frame wall junctions. The underfloor heating also functioned well. It found air infiltration in some floor-to-ceiling window frames at the floor, and in some 'non-orthogonal' frames (without right-angles). It also found air leakage on some fire exits and external doors to the drama studio, with potential discomfort in these spaces. Additionally, the survey found thermal bridging at non-orthogonal corners and junctions, and in one of the windows in the administration block, due to discontinued insulation.
Thomas Paine Study Centre	Thermography evaluated the fabric heat storage strategy, particularly where items and materials, such as a suspended ceiling and plasterboard, had covered the thermal mass of the building. Infrared photos showed there was often poor thermal contact between finishes and the heavyweight building frame, reducing the benefit of thermal mass. For example, imaging easily found discrete dabs of adhesive, showing the lower temperature of the adjacent building core, while the rest of the plasterboard was warmer. The project also used thermography to investigate stratification in rooms. This assessed the displacement ventilation and Termodeck systems.
